Remediation of a 300 bbl Crude Oil Spill Utilizing Gold Crew®

On March 7, 2001 a release of approximately 300 bbl. (12,600 U.S. gal.) of crude oil occurred at a tank battery in northeast Texas resulting in heavy contamination of the site.

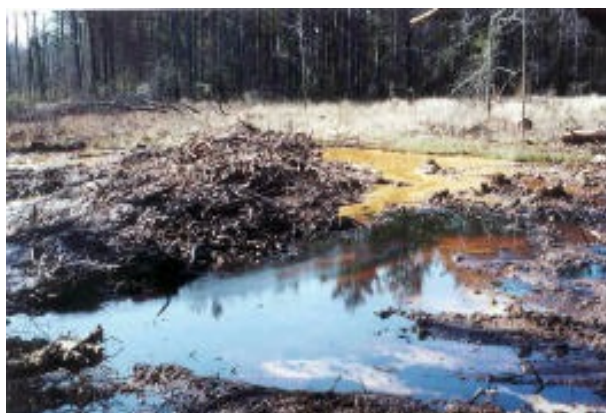
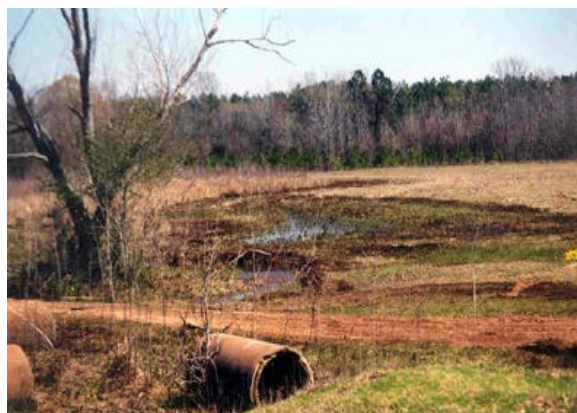
Crude oil released during the spill migrated from the tank battery into an area which was recently cleared and grubbed for a new pasture. This was of particular concern due to the exposed and disturbed soils. There was a tendency for the oil to pool in the locally variable topography, saturating the soil. Crude oil also traveled into an active pasture area which was subsequently isolated and slated for treatment. In addition, the night of the incident there was rainfall of 1.5 inches resulting in water/oil saturated conditions within the soil.

It was decided to utilize "in-situ burning" to remove much of the oil floating on the water contained in the various pools and pockets in the disturbed area. After the burning took place, a vacuum truck was employed to recover any remaining free oil (pooled or floating) within the area. Then a track-hoe was employed to mix, blend and homogenize the soil to an approximate depth of 18 inches, and at the same time provide a uniform grade to the site. Abundant oil was observed leaching from the soil as it was being worked and turned. Because of the very high levels of contamination, no initial soil samples were taken at the outset of the cleanup.

A 3% solution of Gold Crew was then mixed in a 120 bbl (5,040 gal.) transport vessel and sprayed evenly over the impacted areas of the site.

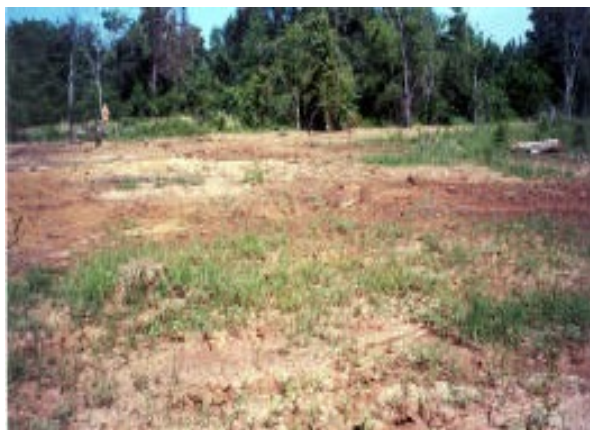
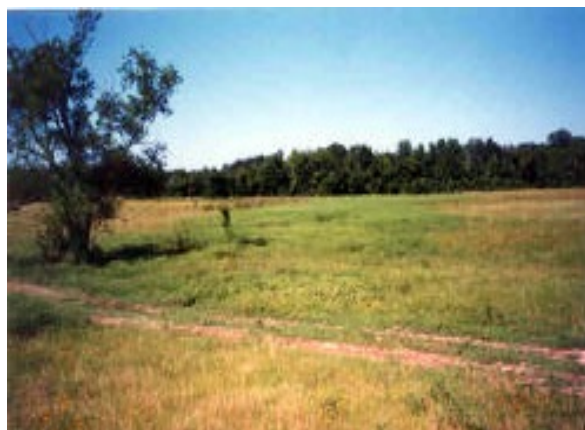
Then the site was left to undergo “enhanced natural attenuation” and visually monitored. Photos below were taken on June 17, 2001 approximately three months after treatment.

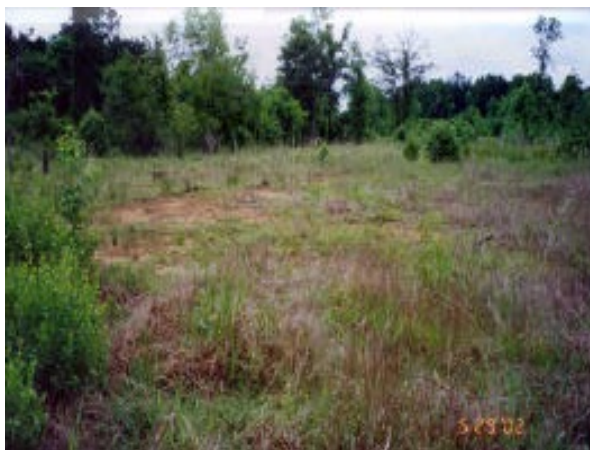
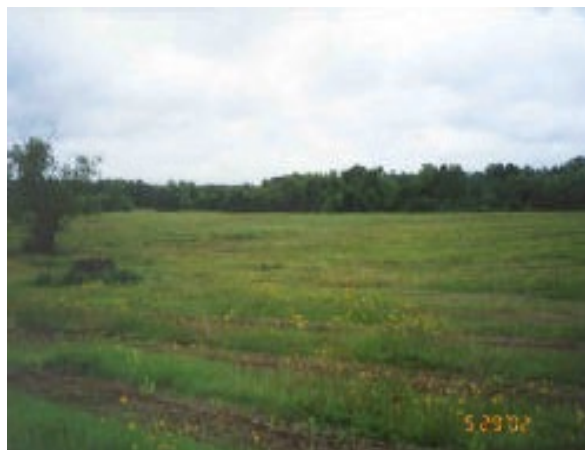
Photos were again taken after approximately one year post-treatment on May 29, 2002. A full vegetative cover is indicative of satisfactory remediation of the pasture area.
